# Neuse River Phase II Watershed Assessment

A review of stream and stormwater outfall conditions and potential restoration and BMP retrofit opportunity in portions of the Neuse River Watershed within the Town of Morrisville

Prepared for:
Town of Morrisville

Prepared by: Stantec Consulting Services Inc.

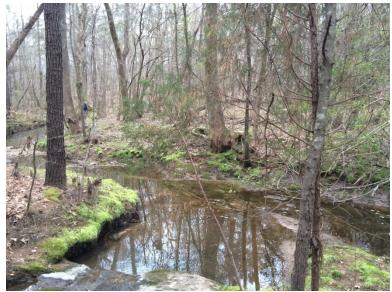
Photo 1 Reach 1-6, example of stable stream in the study area

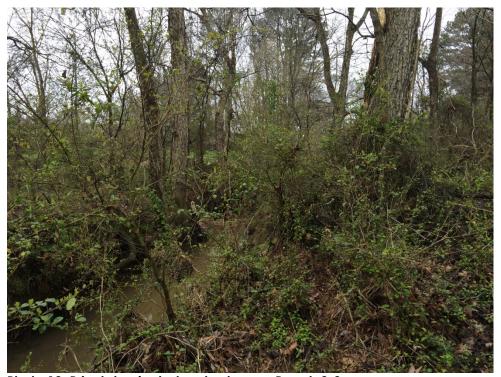
Photo 10. Privet dominated understory on Reach 2-8

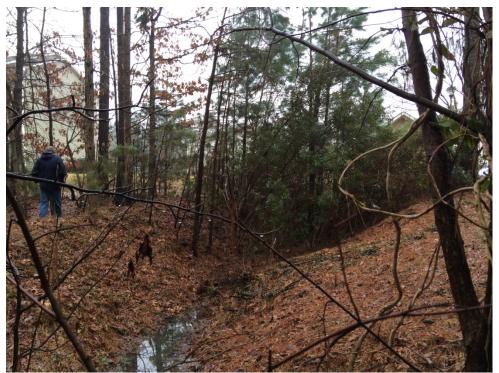
Photo 21 Outfall 37 - buried

in the drainage network. Outfalls 37, 45, 80, and 81 need to be cleaned out to allow for improved flow. Outfall 85 is stable however the channel immediately downstream is eroding and the geotextile fabric is exposed. This area needs to be stabilized with additional rock. Outfall 86 has a broken pipe, however

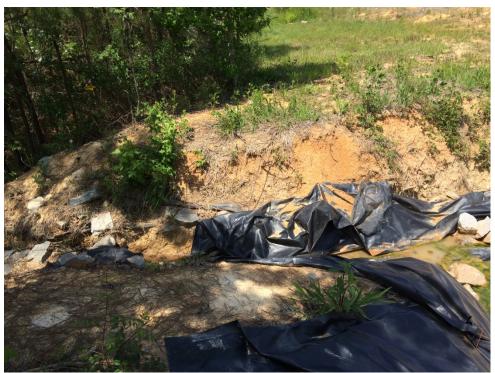
Photo 25 Outfall 85 – downstream of outfall

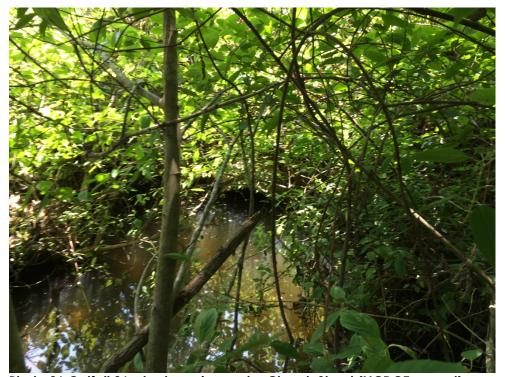
Photo 26 Outfall 86 – broken pipe under Church Street (NCDOT owned)

<sup>\*</sup> outfall owned by NCDOT, repair may impact roadway therefore estimate to repair is not included

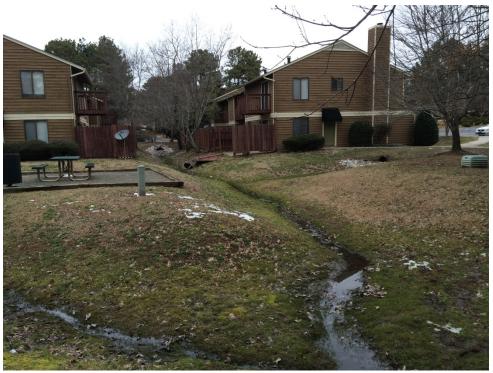
Photo 32. Outfall 26

Outfall 26 is a set of three outfalls that carry runoff from parking lots and buildings in the Treybrooke Gardens apartment complex. The stormwater is briefly above ground before entering another collection system at the edge of the property. Space is limited at the site so the retrofit must be able to be near housing and should not pond water as there are rows of houses within 50 feet downstream of the treatment area. Due to these limitations, an infiltration device such as a bioretention cell may be the most suitable.

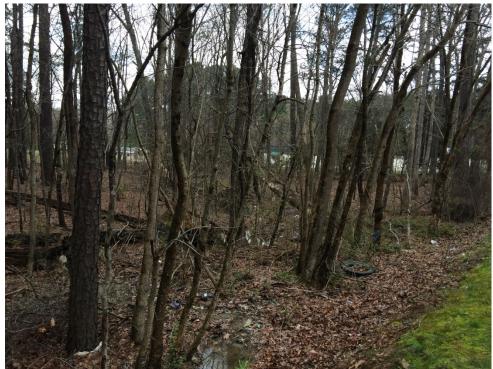
Photo 49. Downstream of Outfall 64

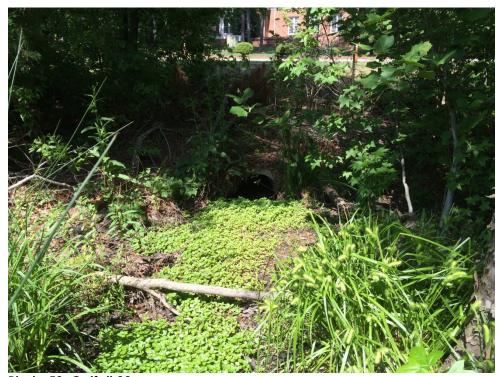
Photo 53. Outfall 88

Outfalls 56 and 88 both carry stormwater from institutional properties including Town offices and discharge at the parking lot of the Indian Creek Greenway and Trailhead Park. While there appears to be ample room to construct a stormwater wetland, a sewer ROW and existing wetlands are present. An additional outfall could be added to the pipe in the trailhead parking lot in order to route stormwater to an additional treatment area found along Town Hall Drive.
