## **Neuse River Phase I Watershed Assessment**

A review of existing stream and BMP  
outfall conditions and potential  
restoration opportunity in portions of  
the Neuse River Watershed within  
the Town of Morrisville

Prepared for:  
Town of Morrisville

Prepared by:  
Stantec Consulting Services Inc.

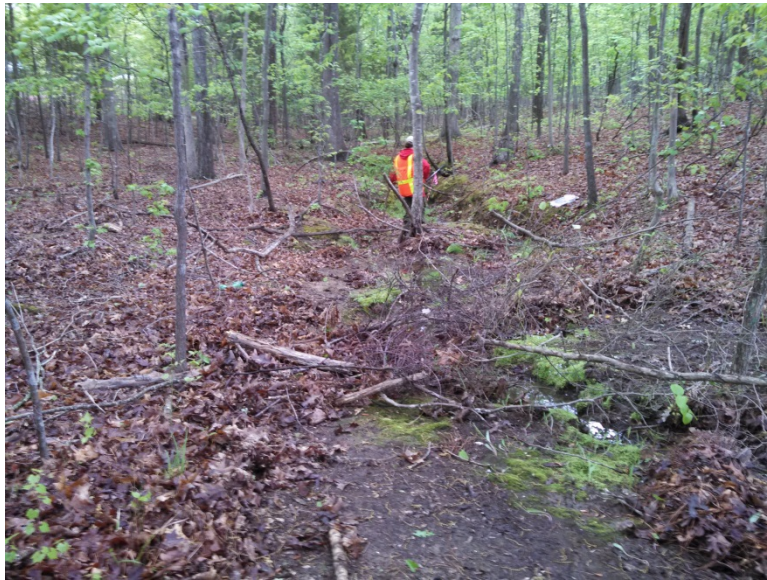
**Photo 1 Reach 2c, example of a stable stream in the study area**

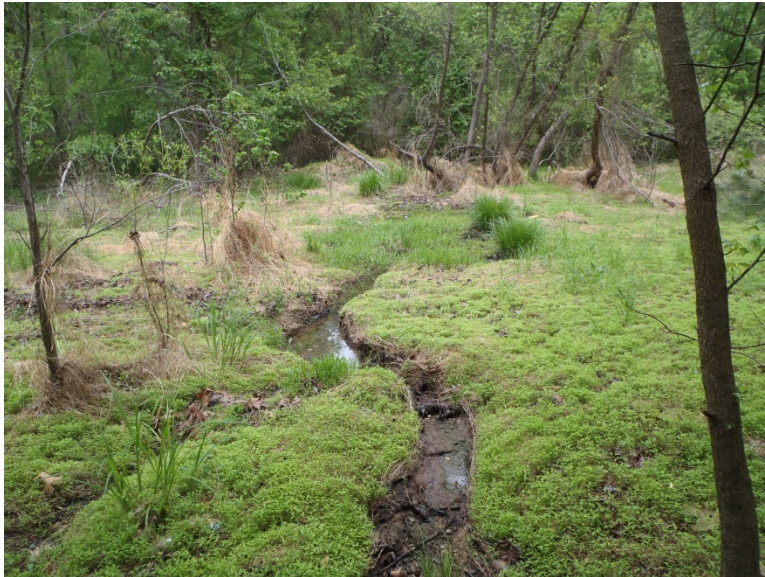
Large stands of invasive species were generally not found in the forested areas. However, invasive species dominated utility line ROWs. Most of the sewer line ROWs in the study area that are located along larger streams with wide floodplains had large areas of *Microstegium vimineum* (stilt grass). Stilt grass seeds are carried by streams and easily establish in disturbed areas such as a newly installed sewer line. Stilt grass was also found in the backwater areas at the confluences of the streams with Lake Crabtree and Stirrup Iron Creek. The only other invasive species worth noting is *Eleagnus umbellata* (autumn olive) which was observed in large clumps at the upstream end of Reach 1-3 and Reach 1k. Autumn olive was also found scattered along other streams, but the populations were not significant enough to quantify.

Photo 3 Invasive species, *Microstegium vimineum*, in sewer line right-of-way (Reach 1a)

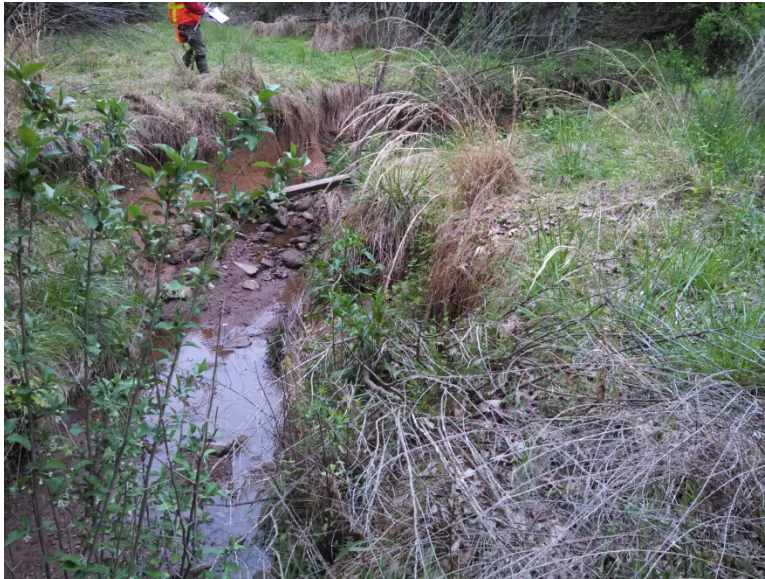
**Photo 4 Reach 1b**

Reach 1b was visited in April, 2014, and found to be incised with eroding streambanks and active headcutting. The Reach is approximately 155 feet long, extending from Outfall 1-2 down valley to Reach 1-2. The channel is 4 to 8 feet wide and 3 to 4 feet deep, with a headcut migrating up valley. The valley is wide and unconfined. The recommended restoration approach is Priority 1, consisting of a new channel re-connected to the existing floodplain. The benefits of this restoration opportunity include improved water quality and habitat, reductions in downstream sedimentation, and prevention of continued headcutting. Estimated cost for design, permitting, construction, and planting is \$374 per foot or \$57,970 for the total reach length.

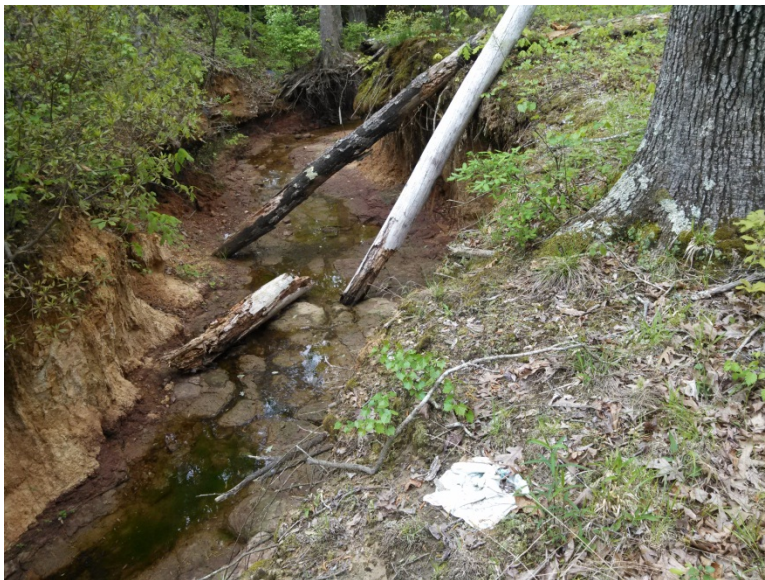
**Photo 5 Reach 1j**

Reach 1j was visited in April, 2014, and found to be incised with eroding streambanks and active headcutting. The Reach is approximately 1,242 feet long, extending from Outfall 1-15 down

valley to Reach 1-3. The channel is 3 to 10 feet wide and 2 to 8 feet deep, with a headcut migrating up valley. The valley is wide and unconfined. The recommended restoration approach is Priority 1, consisting of a new channel re-connected to the existing floodplain. The benefits of this restoration opportunity include improved water quality and habitat, reductions in downstream sedimentation, and prevention of continued headcutting. Estimated cost for design, permitting, construction, and planting is \$464,508 for the total reach length.

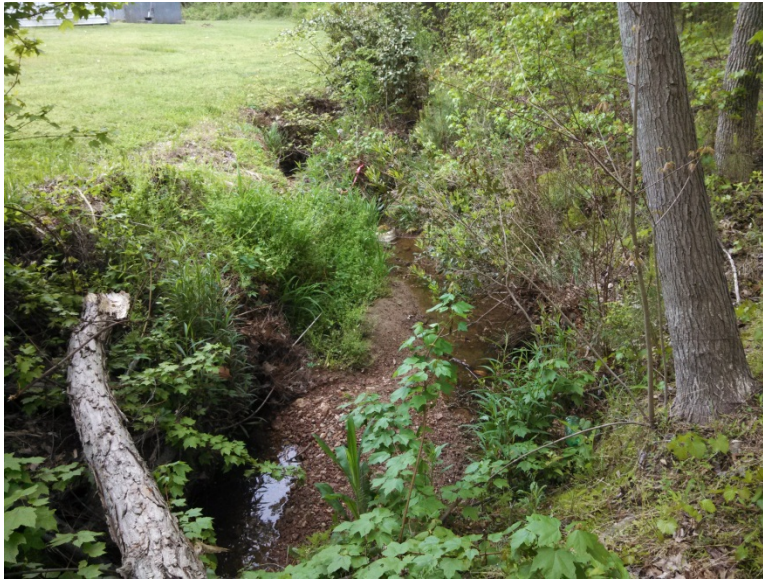
**Photo 6 Reach 1k**

Reach 1k was visited in April, 2014, and found to be incised with eroding streambanks and active headcutting. The Reach is approximately 269 feet long, extending from Outfall 1-20 down valley to Reach 1-4. The channel is 2 to 4 feet wide and 2 to 4 feet deep, with a headcut migrating up valley. The valley is wide and unconfined. The recommended restoration approach is Priority 1, consisting of a new channel re-connected to the existing floodplain. The benefits of this restoration opportunity include improved water quality and habitat, reductions in downstream sedimentation, and prevention of continued headcutting. Estimated cost for design, permitting, construction, and planting is \$100,606 for the total reach length.

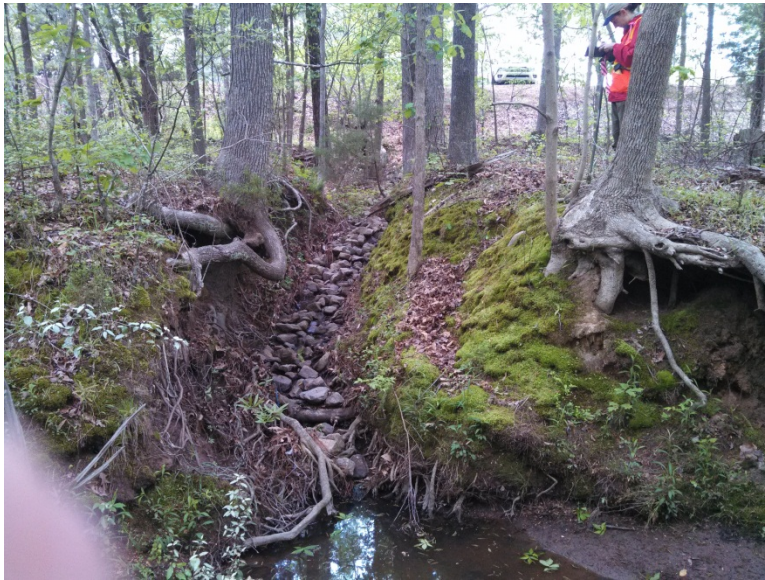
**Photo 7 Reach 1I**

Reach 1l was visited in April, 2014, and found to be incised with eroding streambanks and active headcutting. The Reach is approximately 98 feet long, extending from Outfall 1-22 down valley to Reach 1-3. The channel is 5 to 8 feet wide and 4 to 6 feet deep, with a headcut migrating up valley. The valley is wide and unconfined. The recommended restoration approach is Priority 1, consisting of a new channel re-connected to the existing floodplain. The benefits of this restoration opportunity include improved water quality and habitat, reductions in downstream sedimentation, and prevention of continued headcutting. Estimated cost for design, permitting, construction, and planting is \$36,652 for the total reach length.

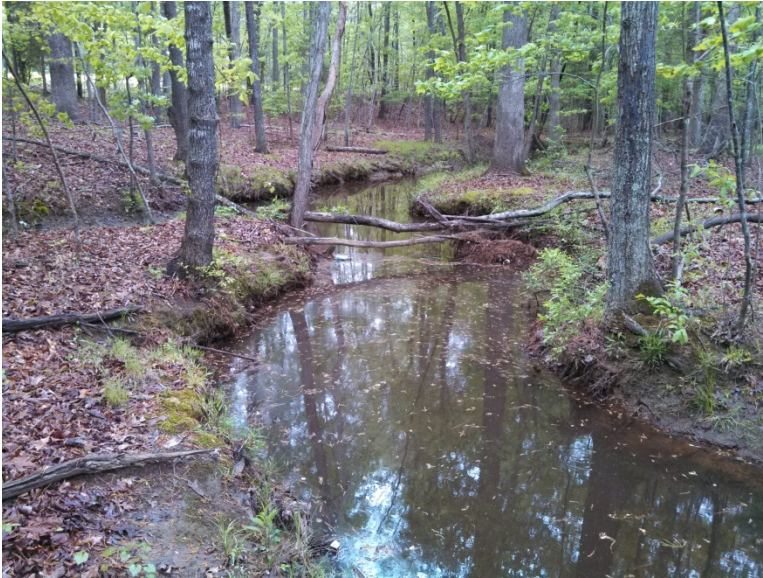
**Photo 8 Reach 2-1**

Reach 2-1 was visited in April, 2014, and found to be incised with eroding streambanks and active headcutting. The Reach is approximately 195 feet long, extending from Reach 2-2 down valley to a wetland at the edge of Town jurisdiction. The channel is 8 to 15 feet wide and 1 to 6 feet deep, with a headcut migrating up valley. The valley is wide and unconfined. The recommended restoration approach is Priority 1, consisting of a new channel re-connected to the existing floodplain. The benefits of this restoration opportunity include improved water quality and habitat, reductions in downstream sedimentation, and prevention of continued headcutting. Estimated cost for design, permitting, construction, and planting is \$72,930 for the total reach length.

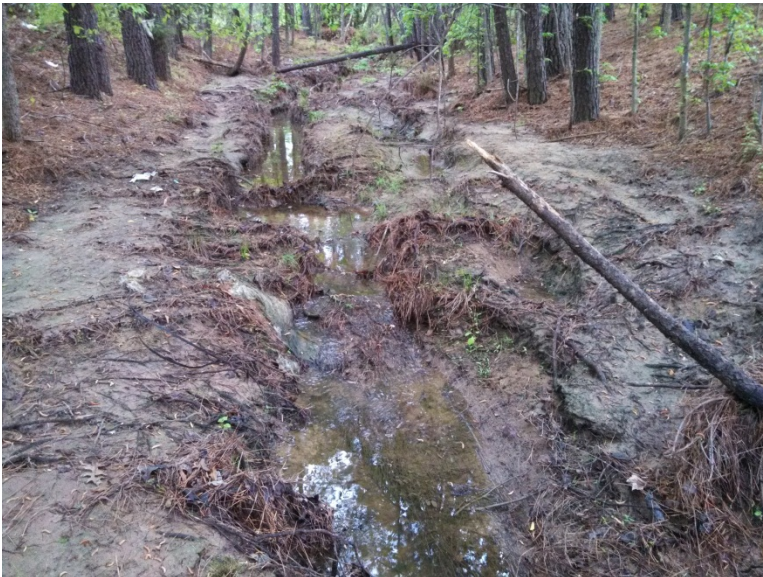
**Photo 9 Reach 2-2**

Reach 2-2 was visited in April, 2014, and found to be incised and widening, with eroding streambanks and active headcutting. Reach 2-2 is approximately 666 feet long, extending from Outfall 2-8 down valley to Reach 2-1. The channel is 2 to 5 feet wide and 1 to 5 feet deep. The valley is narrow and confined. The recommended restoration approach is Priority 1, consisting of a new channel re-connected to the existing floodplain. The benefits of this restoration opportunity include improved water quality and habitat, reductions in downstream sedimentation, and prevention of continued headcutting. Estimated cost for design, permitting, construction, and planting is \$249,084 for the total reach length.

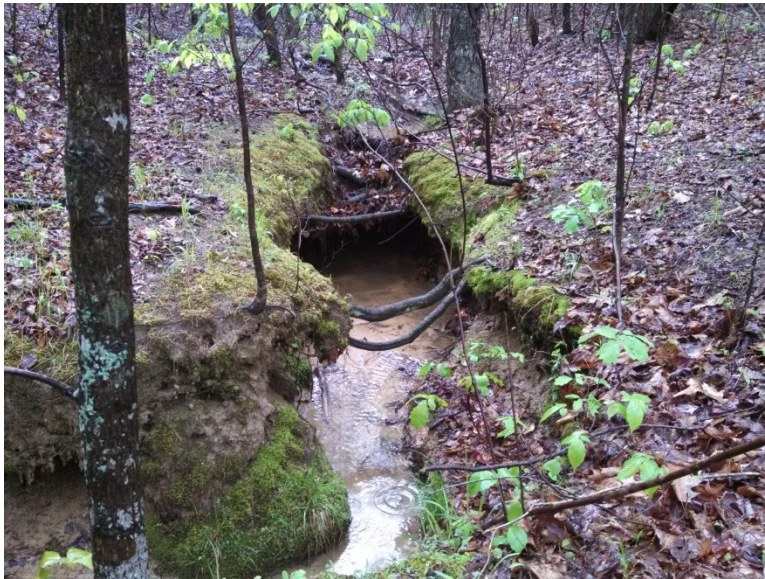
**Photo 10 Reach 5-1**

Reach 5-1 was visited in April, 2014, and found to be incised with eroding streambanks and active headcutting. The Reach is approximately 491 feet long, extending from Outfall 5-1 down valley to the edge of Town jurisdiction. The channel is 2 to 5 feet wide and 1 to 5 feet deep, with a headcut migrating up valley. The valley is wide and unconfined. The recommended restoration approach is Priority 1, consisting of a new channel re-connected to the existing floodplain. The benefits of this restoration opportunity include improved water quality and habitat, reductions in downstream sedimentation, and prevention of continued headcutting. Estimated cost for design, permitting, construction, and planting is \$183,634 for the total reach length.

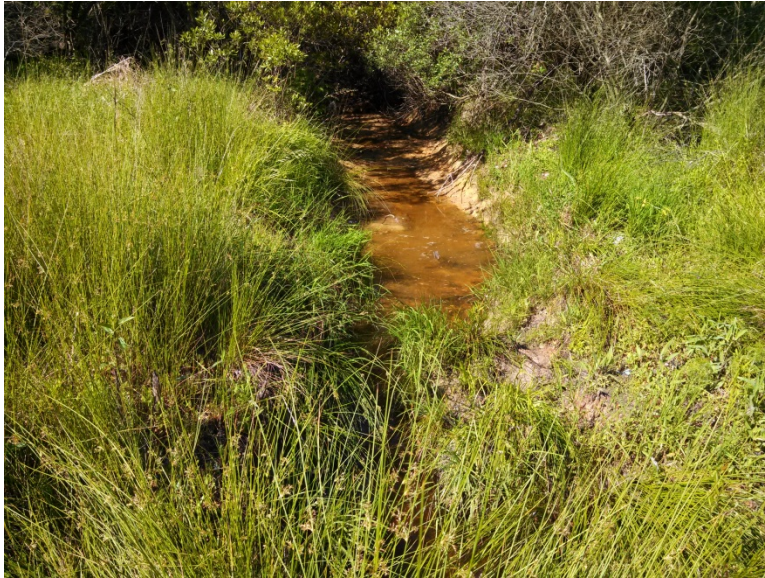
**Photo 11 Reach 6b**

Reach 6b was visited in April, 2014, and found to be incised with eroding streambanks and active headcutting. The Reach is approximately 155 feet long, extending from its ephemeral origin down valley to Reach 6b. The channel is 3 to 5 feet wide and 3 to 4 feet deep, with a headcut migrating up valley. The valley is wide and unconfined. The recommended restoration approach is Priority 1, consisting of a new channel re-connected to the existing floodplain. The benefits of this restoration opportunity include improved water quality and habitat, reductions in downstream sedimentation, and prevention of continued headcutting. Estimated cost for design, permitting, construction, and planting is \$57,970 for the total reach length.

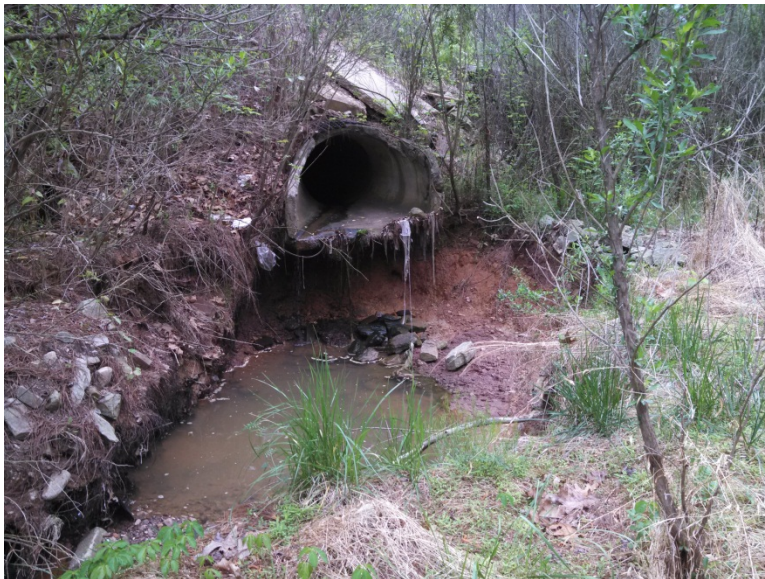
**Photo 12 Outfall 1-2**

Outfall 1-2. This pipe drains a street network to Reach 1b. The pipe is elevated above a scour pool on the floodplain of Reach 1b. The recommendation for stabilization is to add large rock that will maintain position on the streambank to prevent erosion and headcutting. Estimated cost of materials and installation is \$4,000. This cost is for construction only and assumes that design can be performed by the Town.

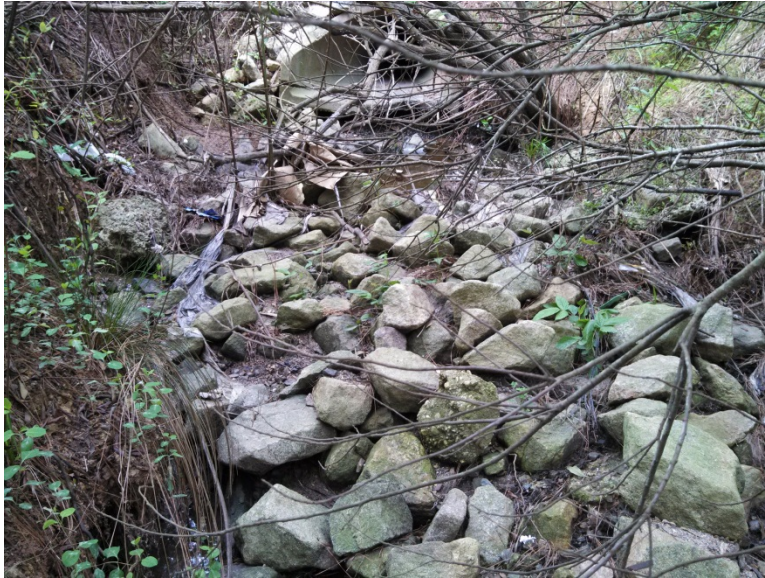
**Photo 13 Outfall 1-6**

Outfall 1-6. This pipe drains a street network to Reach 1g. The pipe discharges to a conveyance channel that is headcutting toward the outfall, potentially undermining the headwall and contributing sediment to the stream. The recommendation for stabilization is to add armoring rock to the conveyance channel to maintain channel stability and prevent headcutting. Estimated cost of materials and installation is \$4,000. This cost is for construction only and assumes that design can be performed by the Town.

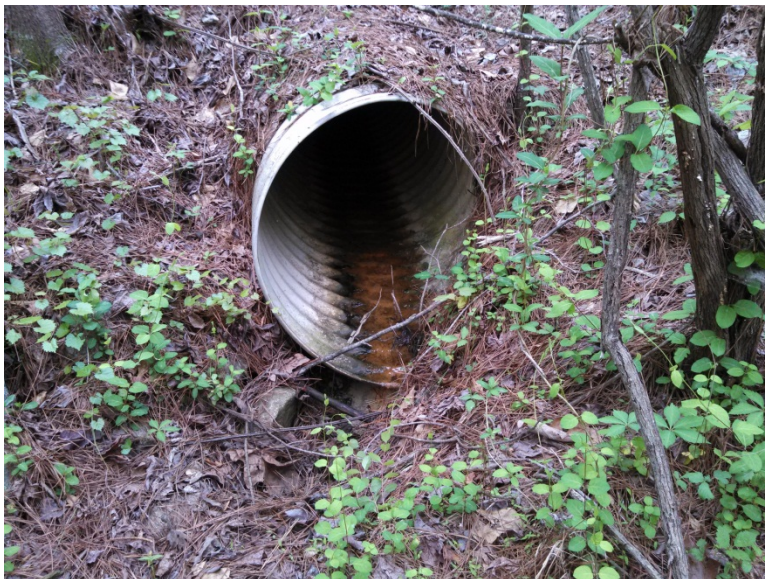
**Photo 14 Outfall 1-10**

Outfall 1-10. This channel drains a wet pond to Reach 1i. The pond dam is failing due to seepage and overtopping. The recommendation for stabilization is to repair the dam and to add armoring rock to the conveyance channel to maintain channel stability and prevent headcutting. Estimated cost of materials and installation is \$10,000. This cost is for construction only and assumes that design can be performed by the Town.

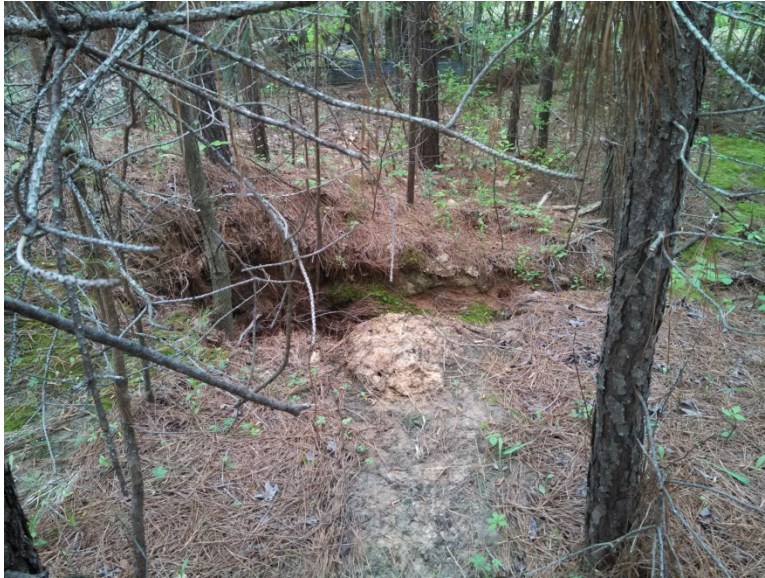
**Photo 15 Outfall 1-10 dam failure**

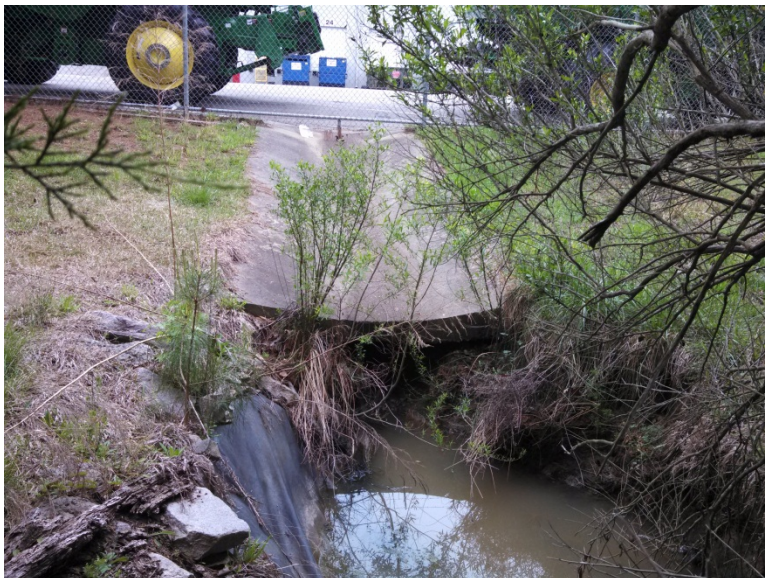
**Photo 16 Outfall 1-11**

Outfall 1-11. This concrete flume drains a parking lot to Reach 1ja. The flume discharges to a conveyance channel that is actively headcutting toward the outfall, undermining the structure and contributing sediment to the stream. The recommendation for stabilization is to add armoring rock to the conveyance channel to maintain channel stability and prevent headcutting. Estimated cost of materials and installation is \$4,000. This cost is for construction only and assumes that design can be performed by the Town.

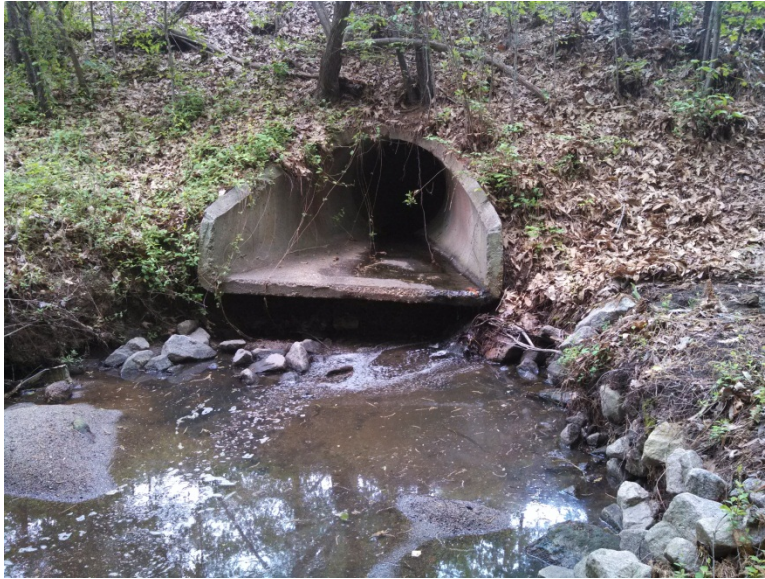
**Photo 17 Outfall 1-22**

Outfall 1-22. This pipe drains a street network to Reach 1l. The pipe discharges to a conveyance channel that is actively headcutting toward the outfall, undermining the structure and contributing sediment to the stream. The recommendation for stabilization is to add armoring

rock to the conveyance channel to maintain channel stability and prevent headcutting. Estimated cost of materials and installation is \$4,000. This cost is for construction only and assumes that design can be performed by the Town.

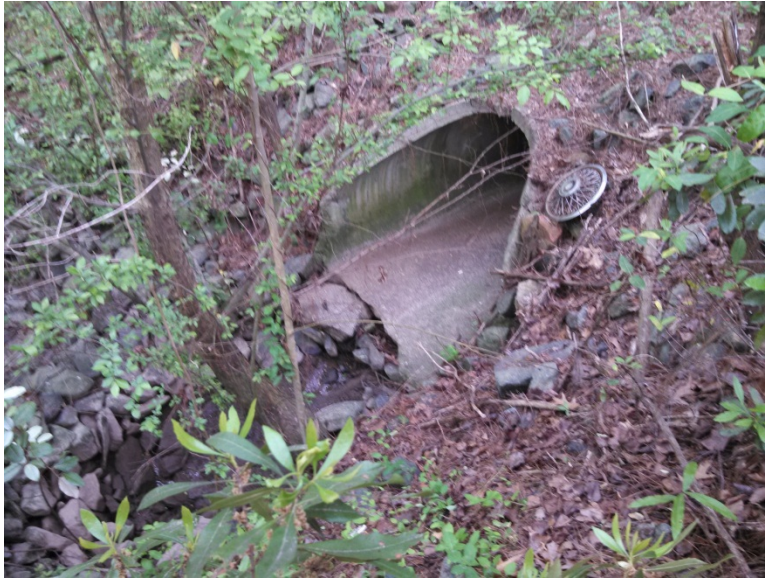
**Photo 18 Outfall 1-25**

Outfall 1-25. This pipe drains a parking lot to Reach 1ja. The pipe discharges to a conveyance channel that is actively headcutting toward the outfall, undermining the structure and contributing sediment to the stream. The recommendation for stabilization is to add armoring rock to the conveyance channel to maintain channel stability and prevent headcutting. Estimated cost of materials and installation is \$4,000. This cost is for construction only and assumes that design can be performed by the Town.

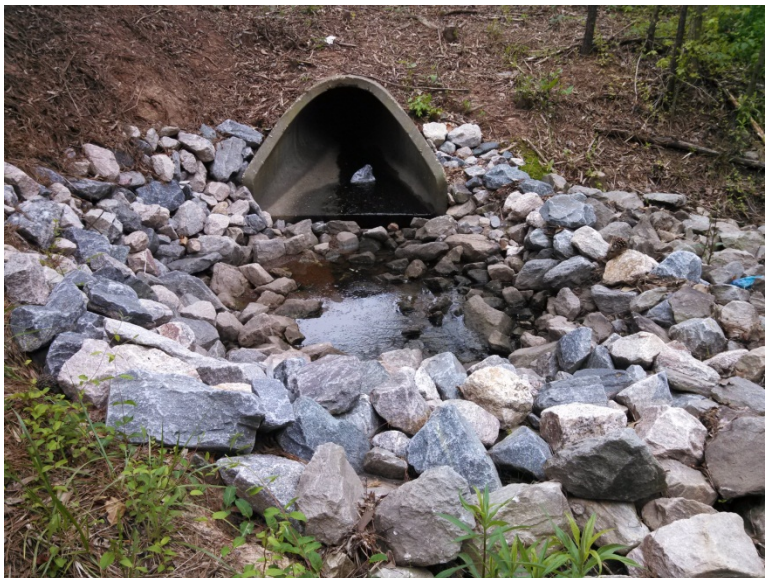
**Photo 19 Outfall 1-26**

Outfall 1-26. This pipe drains a parking lot to Reach 1-4. The pipe discharges to a conveyance channel that is actively headcutting toward the outfall, undermining the structure and contributing sediment to the stream. The recommendation for stabilization is to add armoring rock to the conveyance channel to maintain channel stability and prevent headcutting. Estimated cost of materials and installation is \$4,000. This cost is for construction only and assumes that design can be performed by the Town.

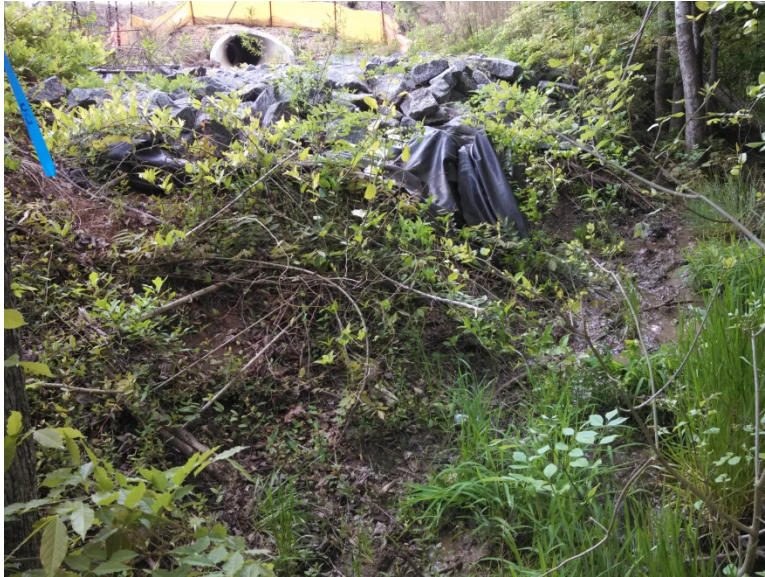
**Photo 20 Outfall 1-28**

Outfall 1-28. This pipe drains a wet pond to Reach 1-4. The pipe discharges to a conveyance channel that is actively headcutting toward the outfall, undermining the structure and contributing sediment to the stream. The recommendation for stabilization is to add armoring

rock to the conveyance channel to maintain channel stability and prevent headcutting. Estimated cost of materials and installation is \$4,000. This cost is for construction only and assumes that design can be performed by the Town.

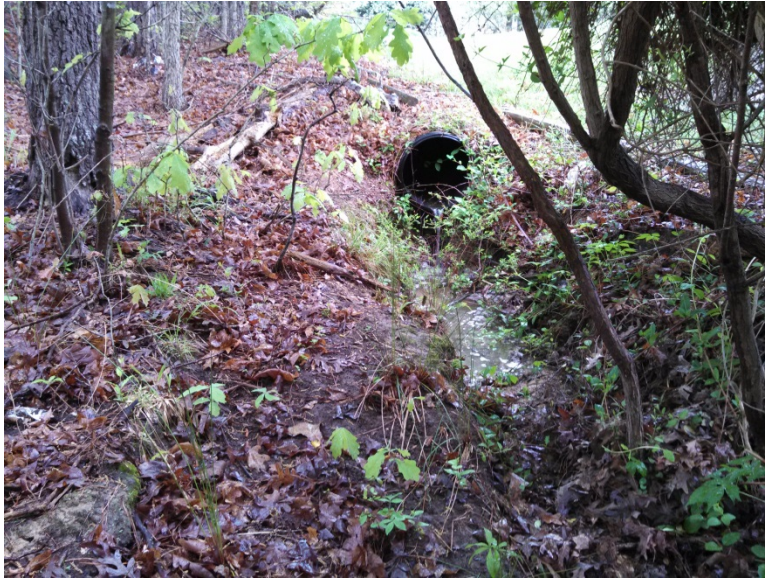
**Photo 21 Outfall 2-10**

Outfall 2-10. This pipe drains a parking lot to Reach 2c-a. The pipe discharges to a conveyance channel that is actively headcutting toward the outfall, undermining the structure and contributing sediment to the stream. The origin of 2c-a is currently on the downstream side of the headcut. The recommendation for stabilization is to add armoring rock to the conveyance channel to maintain channel stability and prevent headcutting. Estimated cost of materials and installation is \$4,000. This cost is for construction only and assumes that design can be performed by the Town.

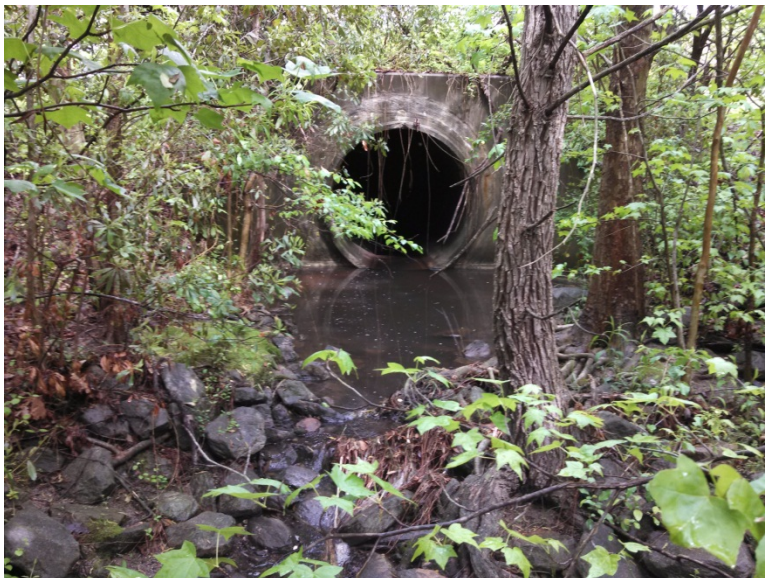
**Photo 22 Outfall L-7**

Outfall L-7. This pipe drains a parking lot to Reach 3-1. The pipe discharges to a conveyance channel that is actively headcutting toward the outfall, undermining the structure and contributing sediment to the stream. The recommendation for stabilization is to add armoring rock to the conveyance channel to maintain channel stability and prevent headcutting. Estimated cost of materials and installation is \$4,000. This cost is for construction only and assumes that design can be performed by the Town.

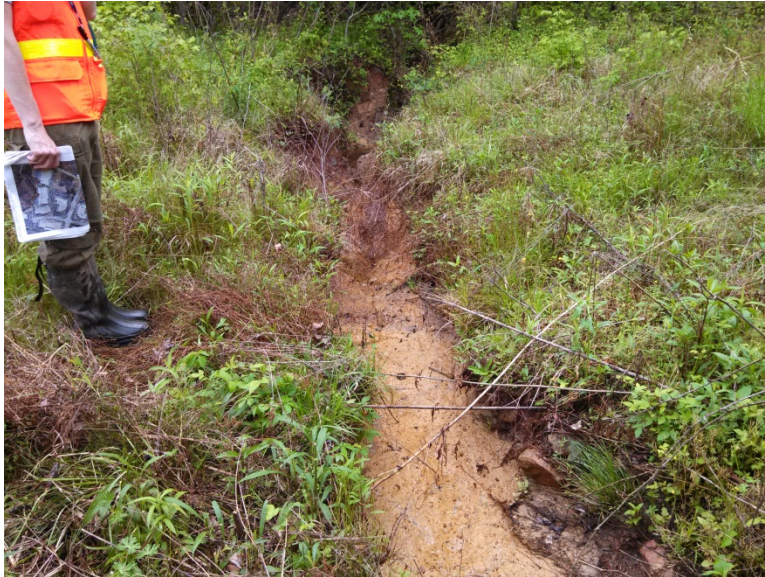
**Photo 23 Outfall L-8**

Outfall L-8. This pipe drains a parking lot to Lake Crabtree. The pipe discharges to a conveyance channel that is actively headcutting toward the outfall, undermining the structure and

contributing sediment to the stream. The recommendation for stabilization is to add armoring rock to the conveyance channel to maintain channel stability and prevent headcutting. Estimated cost of materials and installation is \$4,000. This cost is for construction only and assumes that design can be performed by the Town.

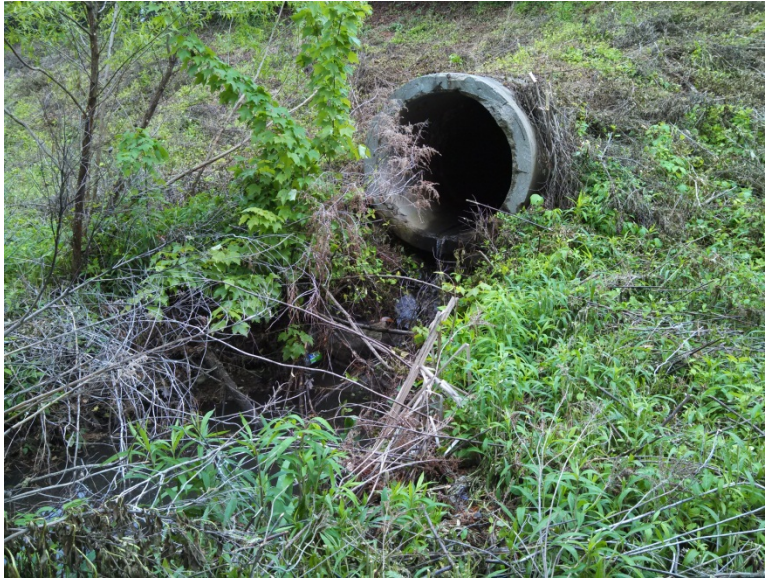
**Photo 24 Outfall L-9**

Outfall L-9. This pipe drains a parking lot to Reach 4-1. The pipe discharges to a conveyance channel that is actively headcutting toward the outfall, undermining the structure and contributing sediment to the stream. The recommendation for stabilization is to add armoring rock to the conveyance channel to maintain channel stability and prevent headcutting. Estimated cost of materials and installation is \$4,000. This cost is for construction only and assumes that design can be performed by the Town.

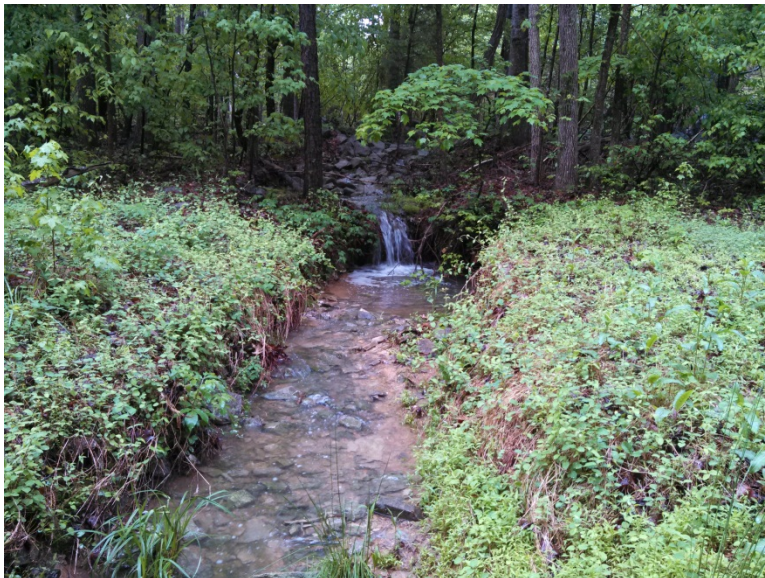
**Photo 25 Outfall L-2**

Channels Downstream of Outfalls L-2 and L-3. Outfall L-2 and L-3 both drain a large warehouse and parking lot. The outfalls are stable and the stormwater discharge flows overland until just upstream of the sewer line ROW. In both cases a channel has started to form. The channels are incised through the ROW and continue to actively headcut towards the outfalls. The recommendation for stabilization is to add armoring rock to the conveyance channel to maintain channel stability and prevent headcutting. The channels are outside of the Town limits and within the Town of Cary's sewer ROW. They have been included in this report since additional headcutting upstream may eventually create a problem in the Town's jurisdiction.
