Morrisville Parkway Access Management Study

From Davis Drive to NC 54 (Chapel Hill Road)

June 18, 2024

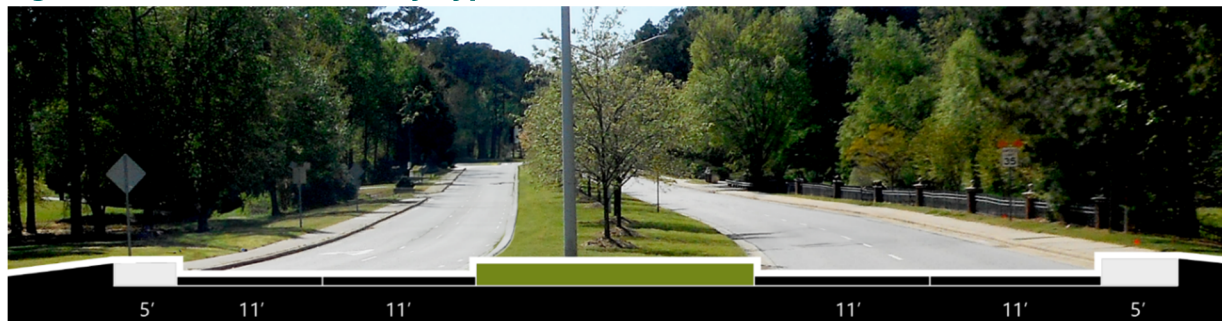
Figure 2 Morrisville Parkway Typical Section

Morrisville Parkway is a four-lane divided arterial with a 35 mile per hour (mph) speed limit. Continuous sidewalks exist along both sides which have varying widths and are either located behind the back of curb or are offset behind the curb with a short planting strip. **Figure 2** below shows the typical cross-section for Morrisville Parkway within this study area.

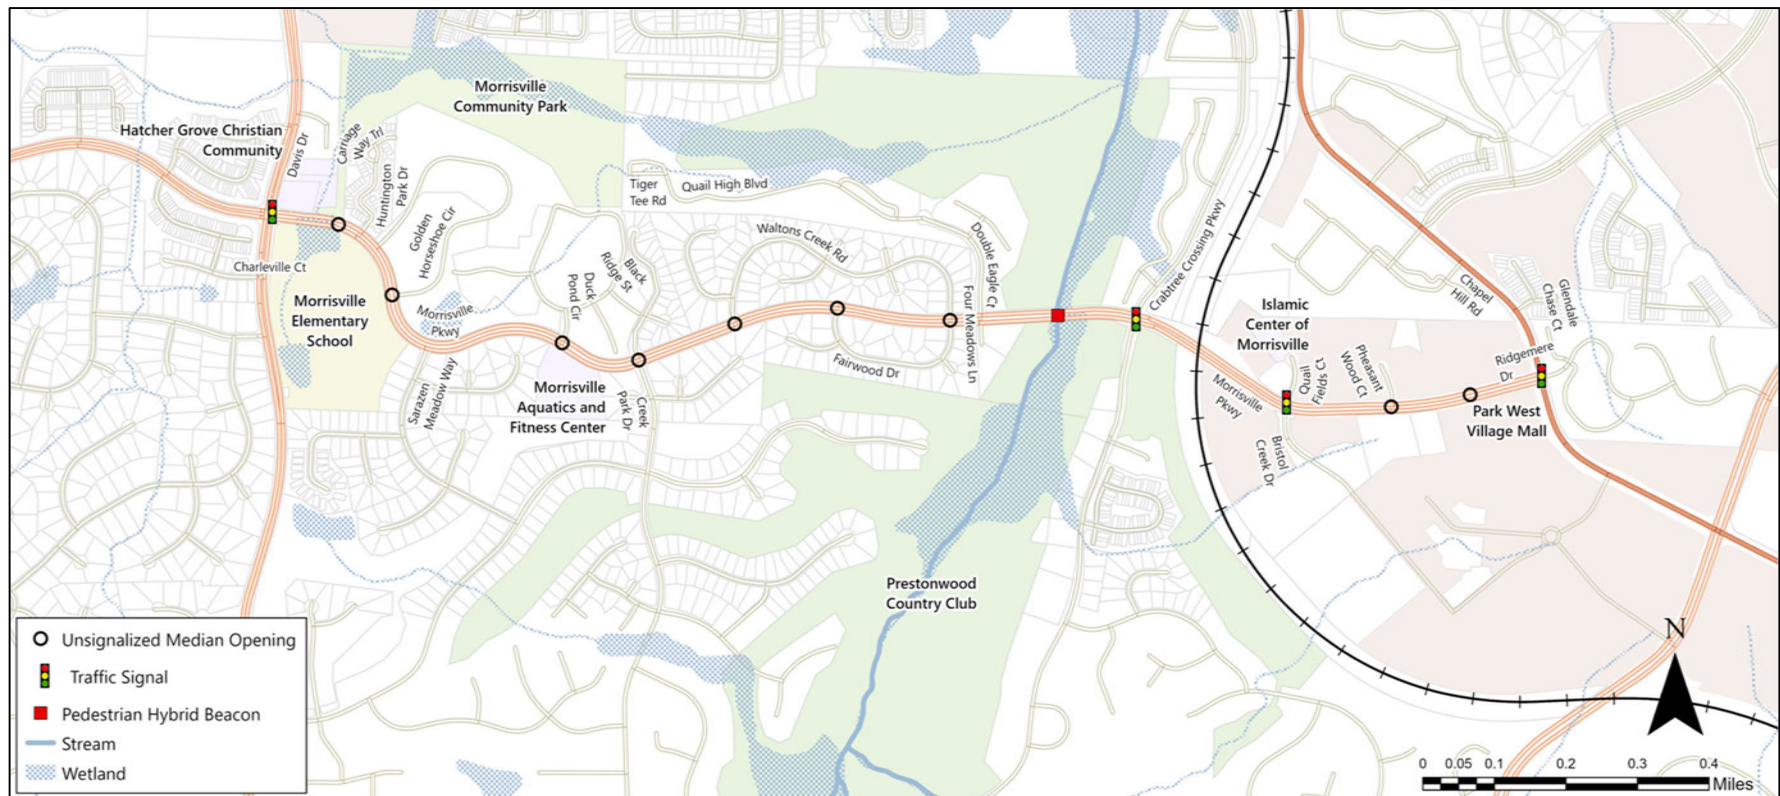
Figure 3 Vicinity Map

The study area was proposed by the Town of Morrisville to cover the portion of the roadway within the Town's limits. The intersections along Morrisville Parkway listed in the next column and shown in **Figure 3** were included in the study area and analyzed for existing and future conditions, where applicable.

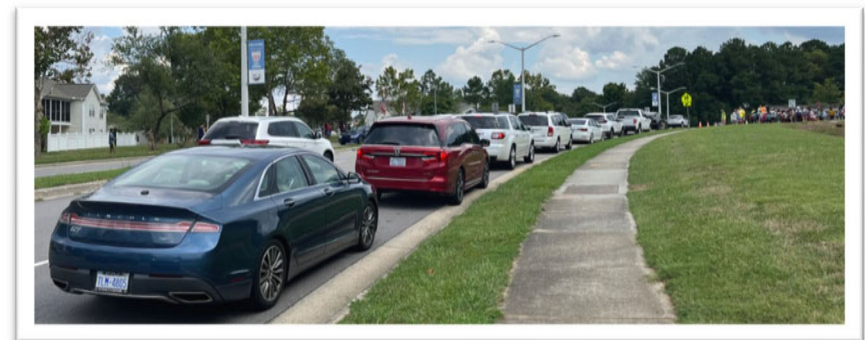
As shown in **Table 2**, the signalized intersection of Morrisville Parkway and Davis Drive is operating at LOS D and LOS E during the AM and PM peak hour, respectively. The other signalized intersections are operating overall at LOS C or better during both peak hours. Quail Fields Court, the southbound approach, is operating at LOS F during both peak hours. The stop-controlled Morrisville Elementary School driveway across from Carriage Way Trail is operating at LOS E during both peak hours. All other stop-controlled approaches within the study area are operating at LOS D or better during both peak hours. While the analysis concentrated on the commuter peaks, there was also considerable congestion as Morrisville Elementary parents arrived prior to the school dismissal period and exceeded the available storage on site (photo below).

Queueing at Morrisville Elementary School During Afternoon Pick-Up

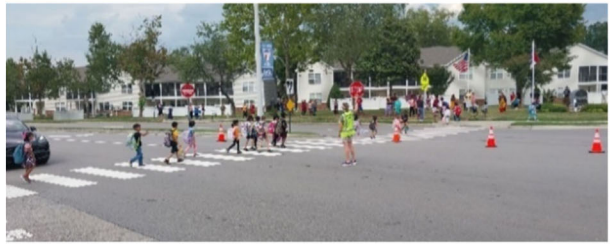
Morrisville Elementary School Students Crossing Morrisville Parkway in High-Visibility Crosswalk.

Based on the TMCs, Morrisville Elementary School/Golden Horseshoe Circle and Morrisville Elementary School/Carriage Way Trail had the most pedestrians during both four-hour periods (AM and PM) counted with a total of 314 and 63, respectively, due to students crossing during drop-off and pick-up times. The next intersections with the most pedestrians were Creek Park Drive/Black Ridge Street, Duck Pond Circle, and Waltons Creek Road with 31, 23, and 20

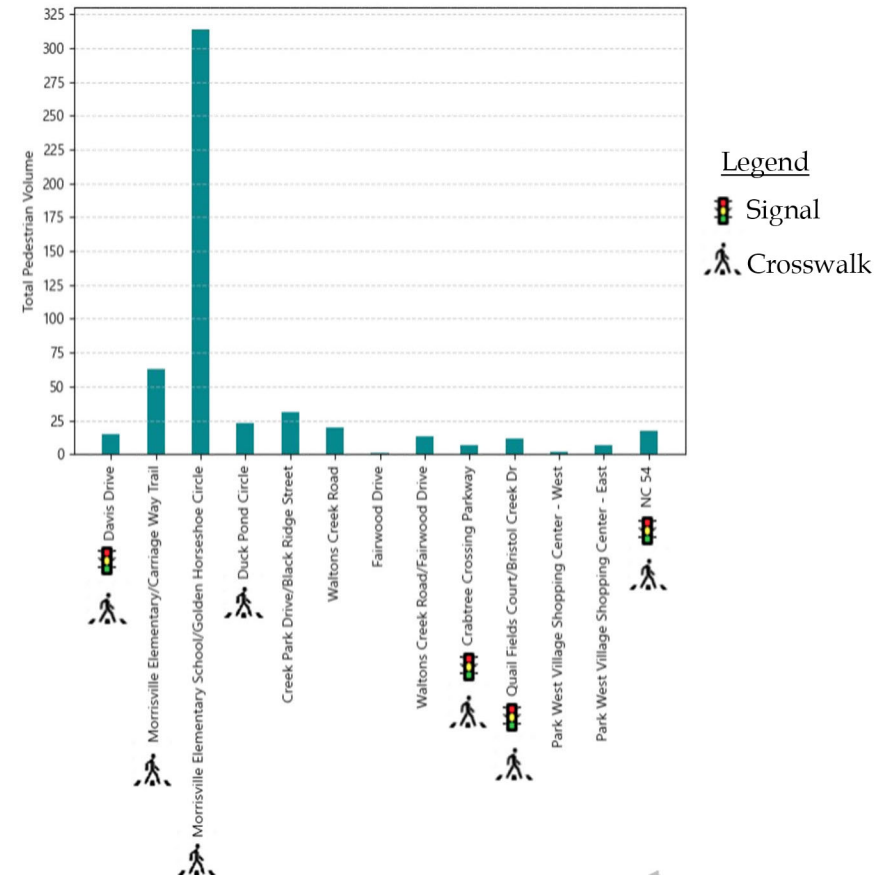
Figure 6 Four-Hour Pedestrians Counts

pedestrians, respectively, which are all near the MAFC. The intersections with the highest vehicular volumes, NC 54 (Chapel Hill Road) and Davis Drive intersections, had 17 and 15 pedestrians, respectively. The total pedestrians counted crossing any approach at each intersection are shown in **Figure 6**, and the symbology indicates whether the intersection is signalized and if crosswalks are present across Morrisville Parkway. Based on feedback from the community, walking across Morrisville Parkway is exceedingly difficult due to the high speeds and volume of traffic. Pedestrians avoid crossing altogether or cross mid-block between intersections in two stages using the median as a refuge.

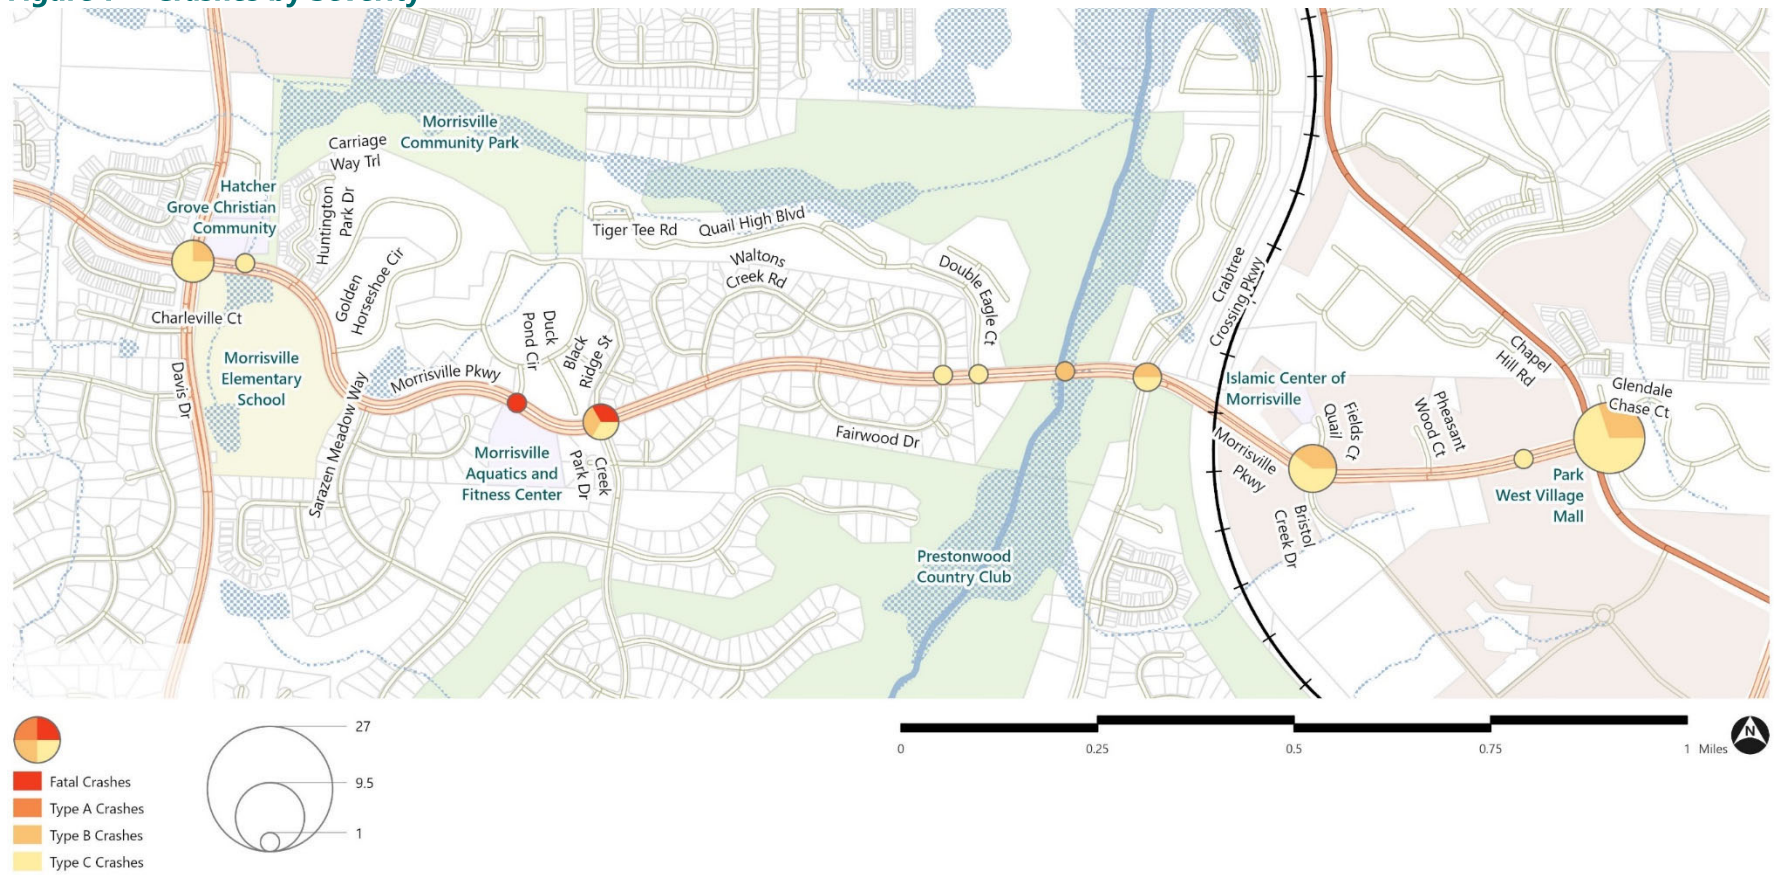
Figure 7 Crashes by Severity

The crashes are shown by type in **Figure 7** and injury crashes are shown by severity in **Figure 8**. Crash Severity is measured by fatal injury, severe injury (Type A), moderate injury (Type B), and minor injury (Type C).

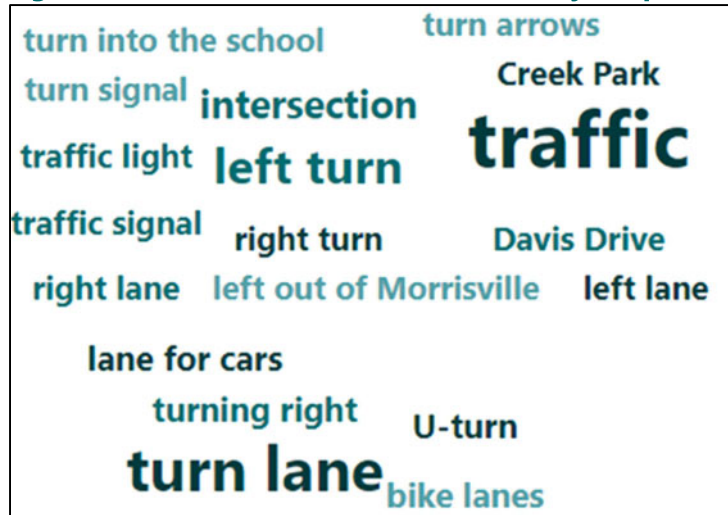
Figure 11 Public Response Areas of Interest

The feedback was generally positive regarding the introduction of additional signals, crosswalks, and turn lanes intended to improve traffic flow and safety. However, several concerns were raised about pedestrian and cyclist safety, the channelization of intersections, and vehicle speeds. The feedback from this phase was visualized in a word cloud, shown in **Figure 10**, that emphasized key concerns and suggestions, reflecting the community's priorities for improvements along Morrisville Parkway. The concentration of comments by location is illustrated in **Figure 11**.

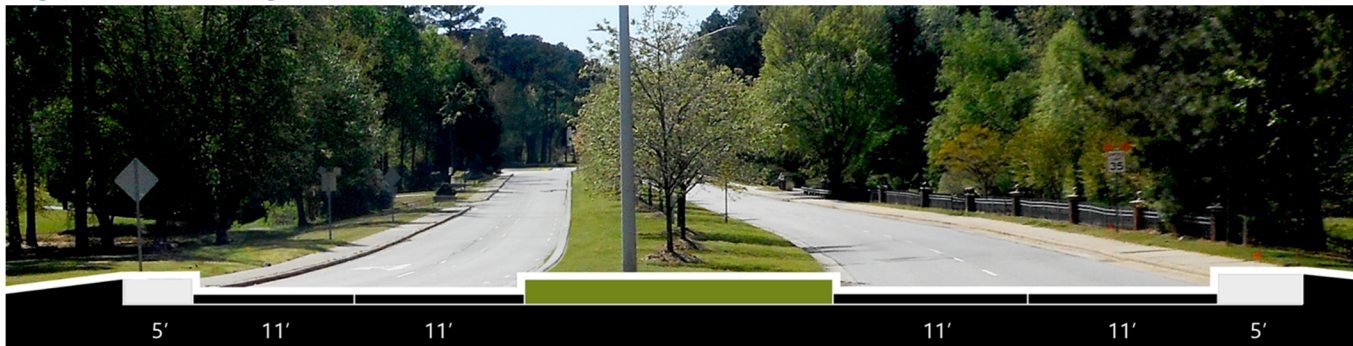
Figure 13 Existing Corridor Cross-Section

Based on the feedback provided from community engagement, crash data analysis, and traffic analyses, several improvements are recommended to enhance safety and mobility along the corridor for pedestrians, cyclists, and drivers. The existing corridor cross-section is shown in **Figure 13** alongside the proposed corridor cross-section in **Figure 14**. The proposed cross-section includes the following:

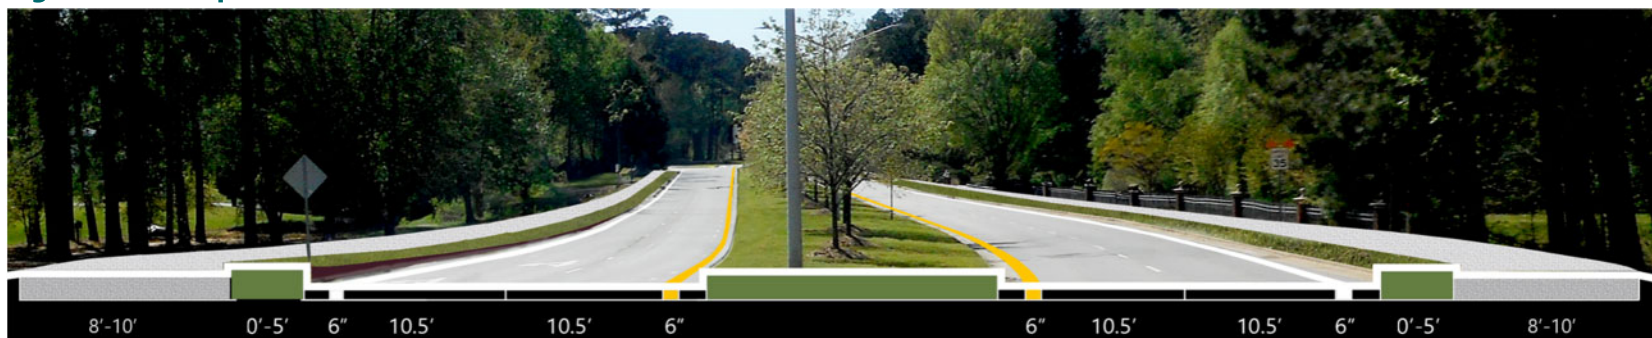
Figure 14 Proposed Corridor Cross-Section

Note that after considerable discussion with the PMT/TSC and review of field conditions, multi-use paths rather than exclusive protected bicycle lanes were selected to accommodate bicycle demand along
